RE: Aquavista of Panama City Owners Association, Inc.

RESERVE STUDY UPDATE

Conducted on November 8, 2010

**Aquavista of Panama City Owners Association, Inc.
Panama City Beach, Florida**

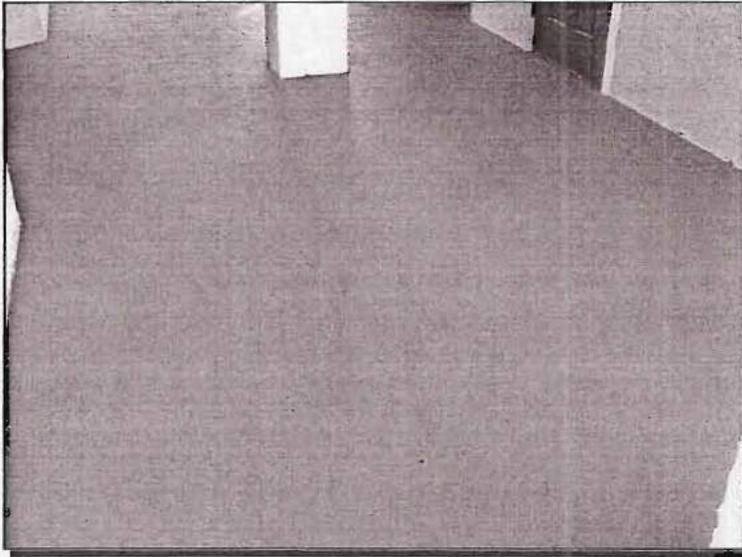
Concrete breezeway

Note: Coated in 2010 through the operating budget

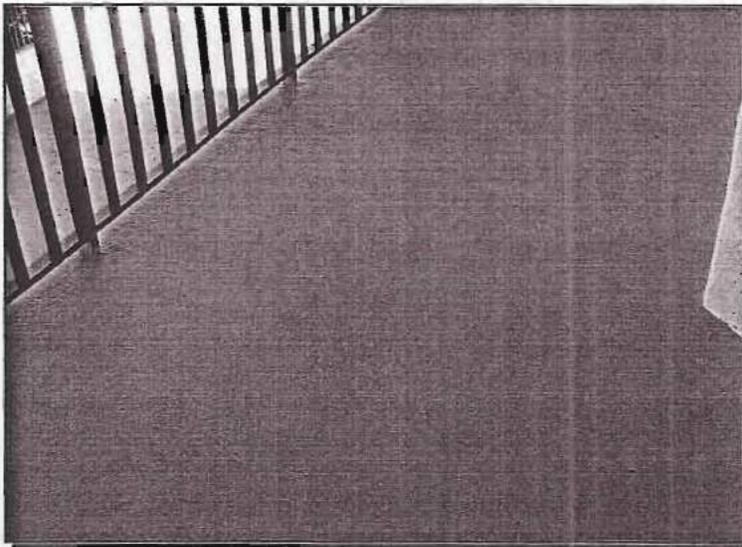
Concrete breezeway

Note: Coated in 2010 through the operating budget

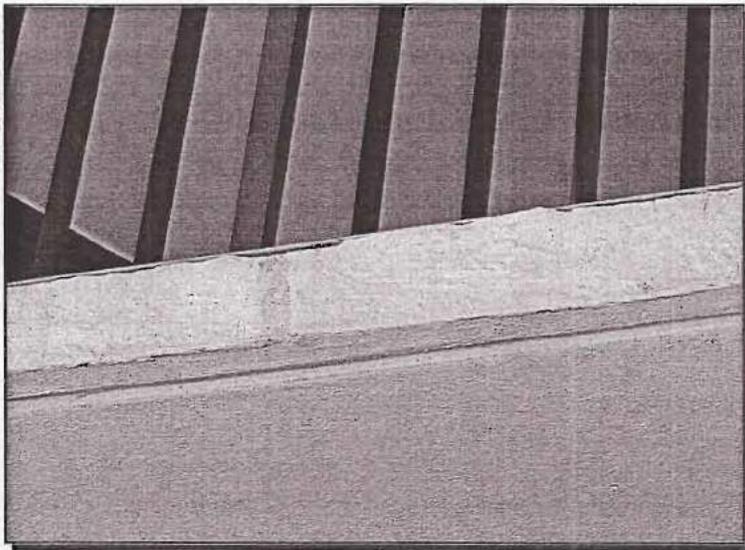
Breezeways and Balconies, Concrete, Repairs - The concrete breezeways and balconies are in good to fair overall condition at an ages of 26- to 27-years. Based on the observed condition and conversations with Management, we now recommend the Association budget for partial depth replacement of less than one percent (0.5%) of the concrete topside, edge and underside of the breezeways and balconies. We recommend the Association budget for this work

Concrete balcony

Note: Minor spalling at top side

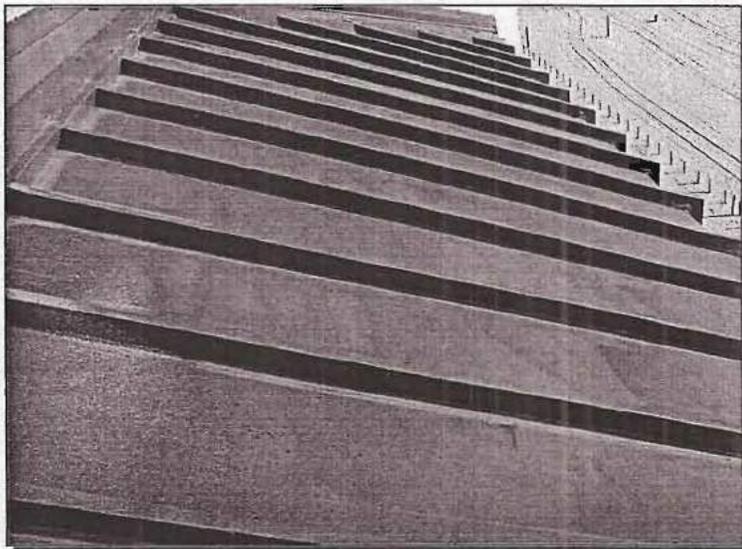
Roofs, Mansard, Metal - The metal roof quantity on the clubhouse has been added to Line Item 9 for a total of 95 squares of standard seam metal roofs. The metal roofs are in fair overall condition at an age of 26- to 27-years. Based on their age and observed condition, we now recommend the Association anticipate complete replacement of the roofs by 2013. We note this significant change in quantity and timing on Line Item 9 in the Exhibit of *Reserve Expenditures*.

Metal mansard roof

Note: Deterioration of finish

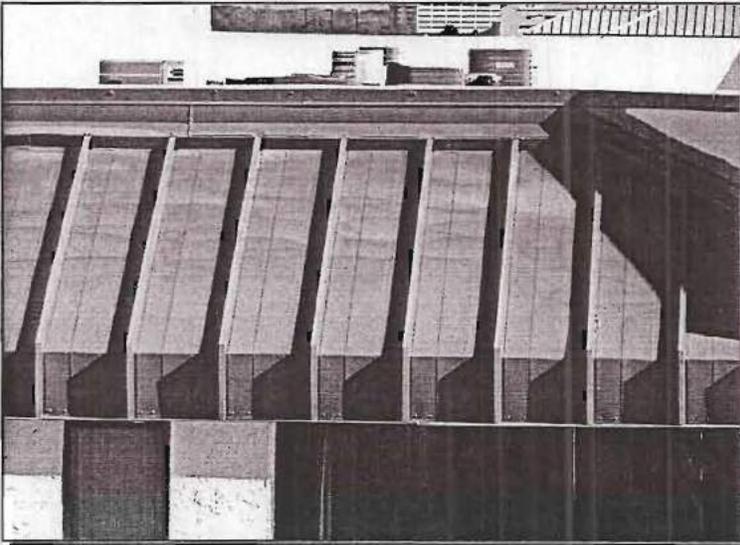
Metal mansard roof

Note: Deterioration of finish

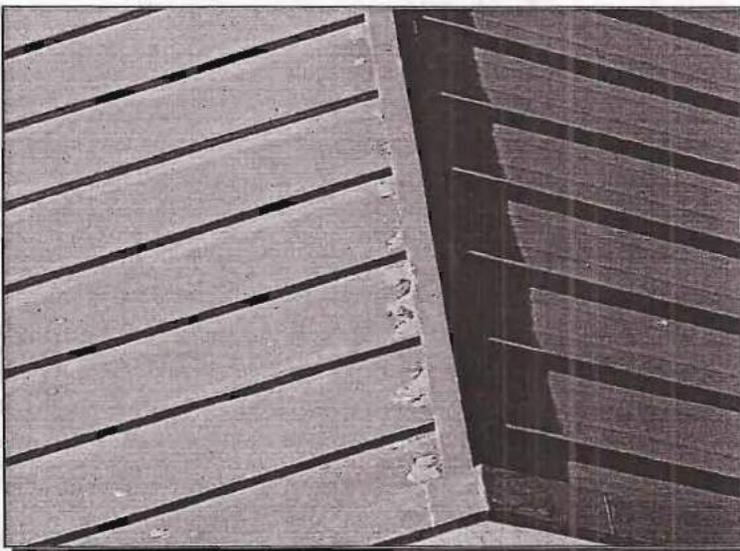
Metal mansard roof

Note: Deterioration of finish

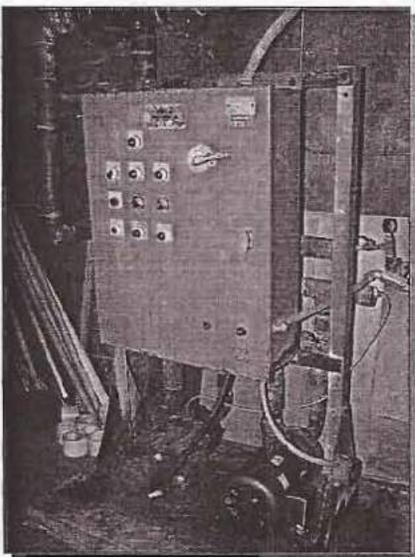
Pumps and Controls, Domestic Water - The domestic water pumps and controls are in good reported operational condition at unknown ages. Based on the observed condition, we now recommend the Association anticipate complete renovation of the pumps and controls by 2012

Domestic booster pumps and control panel

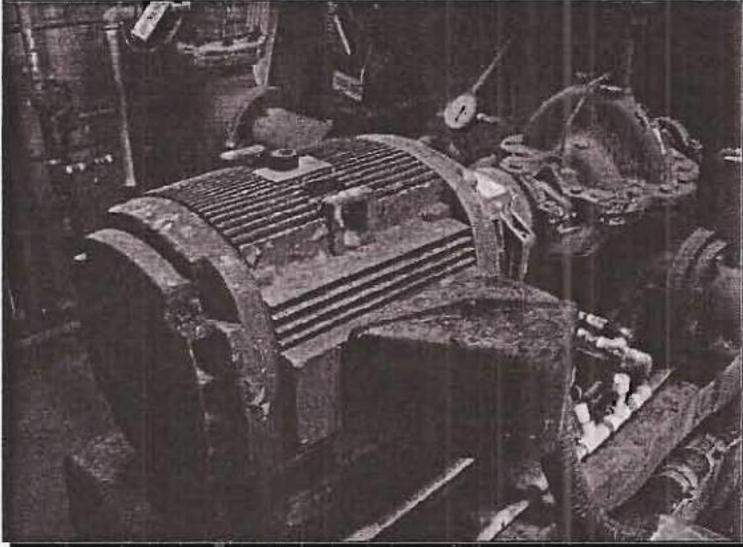
Pumps and Controls, Fire Suppression - The fire suppression pump remains in good reported condition at an age of 27 years. The fire pump control panel has been upgraded since original construction. Based on the age and reported condition, we now recommend the Association defer replacement of the pump and control panel until 2023. We note this significant change in timing on Line Item 17 in the Exhibit of *Reserve Expenditures*.

Fire suppression pump

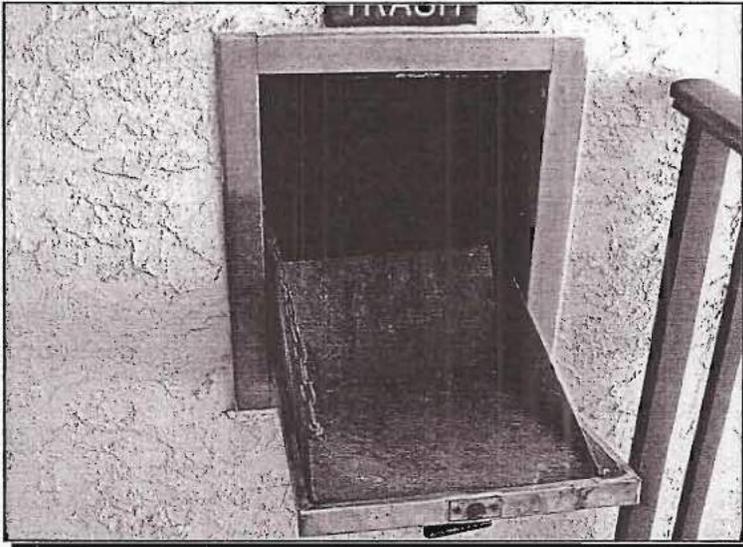
Trash Chutes and Doors - The trash chutes and doors are in fair overall condition at an age of 26- to 27-years. Based on the observed condition, we now recommend the Association accelerate replacement of the trash chutes and doors to 2012. We note this significant change in timing on Line Item 21 in the Exhibit of *Reserve Expenditures*.

Trash chute door

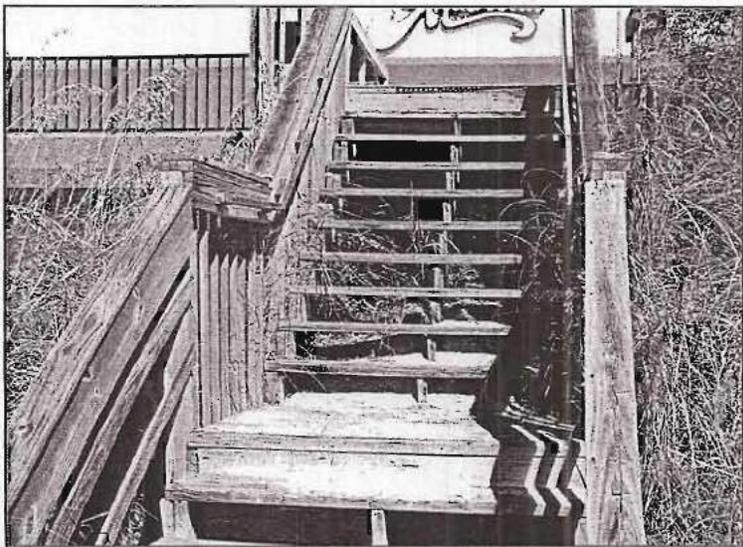
Beach Walk and Stairs - The beach walk and stairs remain in fair overall condition at an age of 27 years. The Association did not replace the beach walk and stairs since our last Reserve Study. Based on the observed condition, we recommend the Association replace the beach walk and stairs by 2012 and again by 2035. We note this significant change in timing on Line Item 22 in the Exhibit of *Reserve Expenditures*.

Wood stairs to access beach

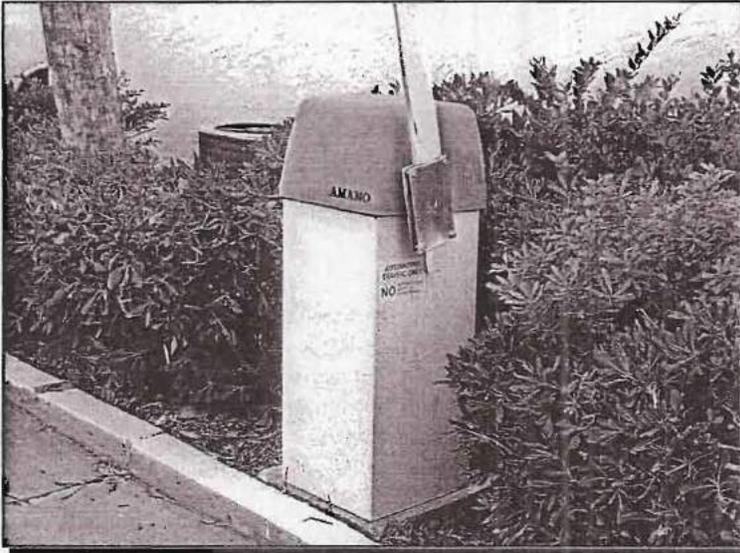
Gates, Swing Arm - The swing arm gate operators remain in fair overall condition at an age of 27 years. The Association did not replace the operators since our last Reserve Study. Based on the observed condition, we recommend the Association replace the operators by 2012 and every ten years thereafter. We note this significant change in timing on Line Item 23 in the Exhibit of *Reserve Expenditures*.

Swing arm operator

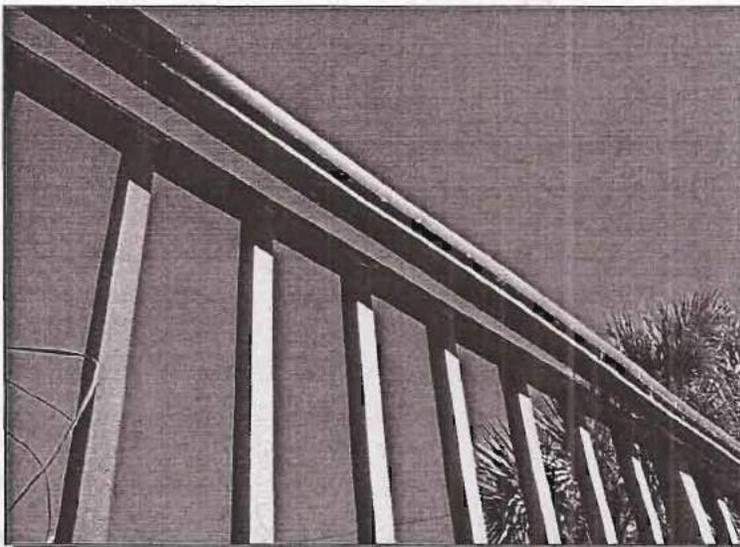
Perimeter Fences and Walls - The stucco perimeter walls are in good to fair condition while the aluminum fences are in poor overall condition at an age of 27 years. The Association did not replace the aluminum fences since our last Reserve Study. Based on the observed condition, we recommend the Association replace the fences and apply paint finishes to the walls

Perimeter fence at front of property

Note: Detachment

by 2012 and again by 2040. We also recommend paint finishes to the walls and fences every six- to eight-years, or by 2019 and every seven years thereafter except when replacement occurs. We note these significant changes on Line Items 24 and 25 in the Exhibit of *Reserve Expenditures*.

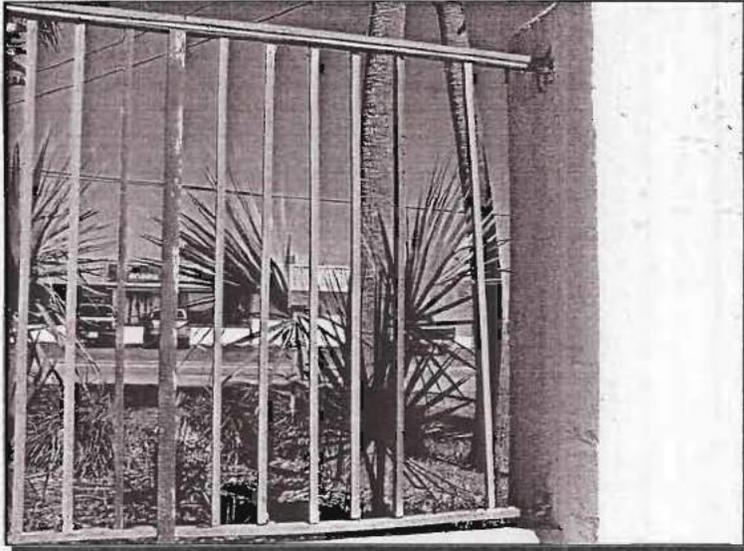
Perimeter fence at front of property

Note: Poor condition of fence

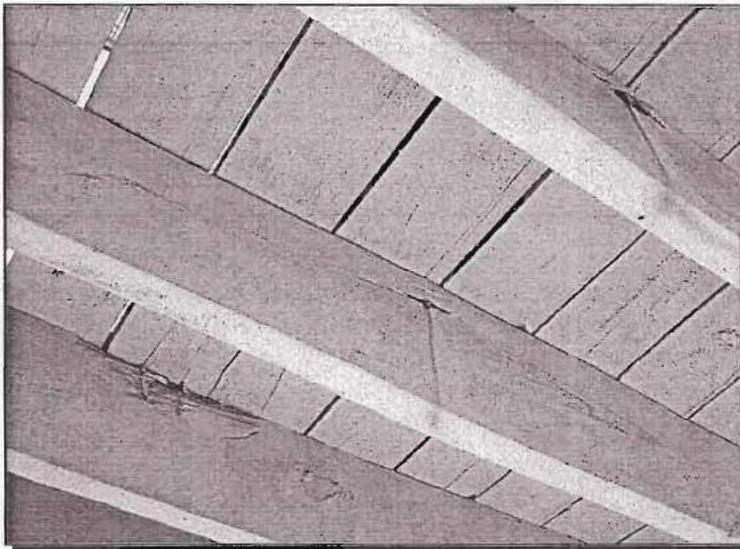
Wood Deck and Stairs - The wood deck and stairs at the clubhouse remain in fair to poor overall condition at an age of 27 years. Based on the observed condition, we recommend the Association replace the wood deck and stairs by 2013 and again by 2036. We note this significant change in timing on Line Item 32 in the Exhibit of *Reserve Expenditures*.

Wood deck at clubhouse

Note: Wood deterioration

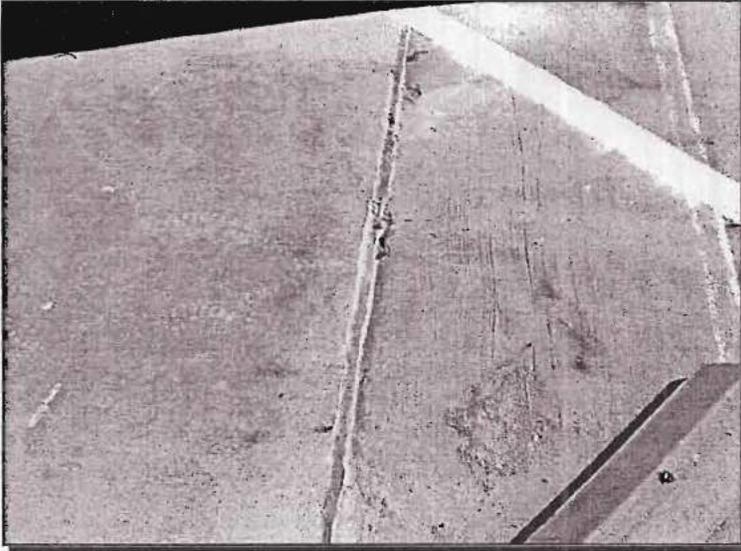
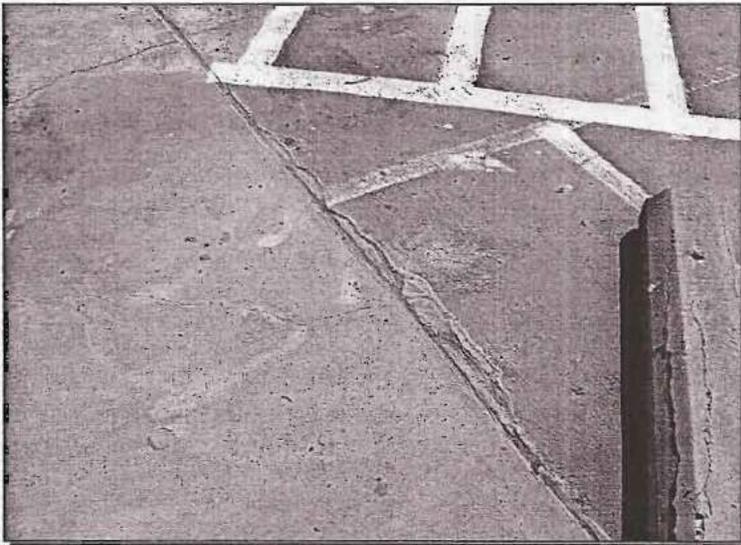
Expansion Joints - The expansion joints remain in good overall condition. Partial replacements of the joints has occurred in the past. Based on the observed condition, we recommend the Association anticipate a complete replacement of the expansion joints by 2021. We note this significant change in timing on Line Item 39 in the Exhibit of *Reserve Expenditures*.

Expansion joint at meeting of
elevated and on-grade concrete

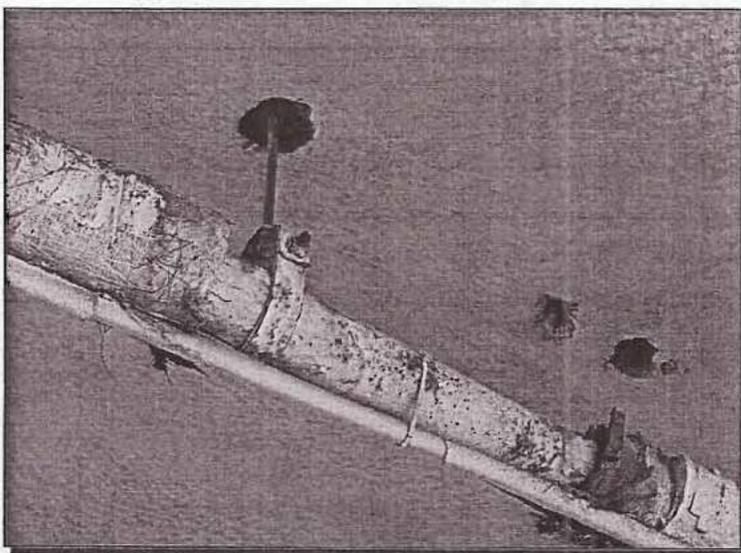
Pipes and Hangers, Paint Finishes and Repairs - Aquavista maintains various pipes and associated metal hangers in the garage. The pipe finishes and hangers are in fair to poor overall condition at unknown ages. We recommend the Association budget for paint finishes to the pipes and partial hanger replacements every 12 to 15 years, or by 2012, 2027 and again by 2039. We depict this information on Line Item 41 in the Exhibit of *Reserve Expenditures*.

Pipe and pipe hangers at garage

Note: Displaced hanger
